# Supplemental: Miscellaneous Topics

## DEW-Demolition Contrary Evidence

*By Dr. Gregory S. Jenkins*

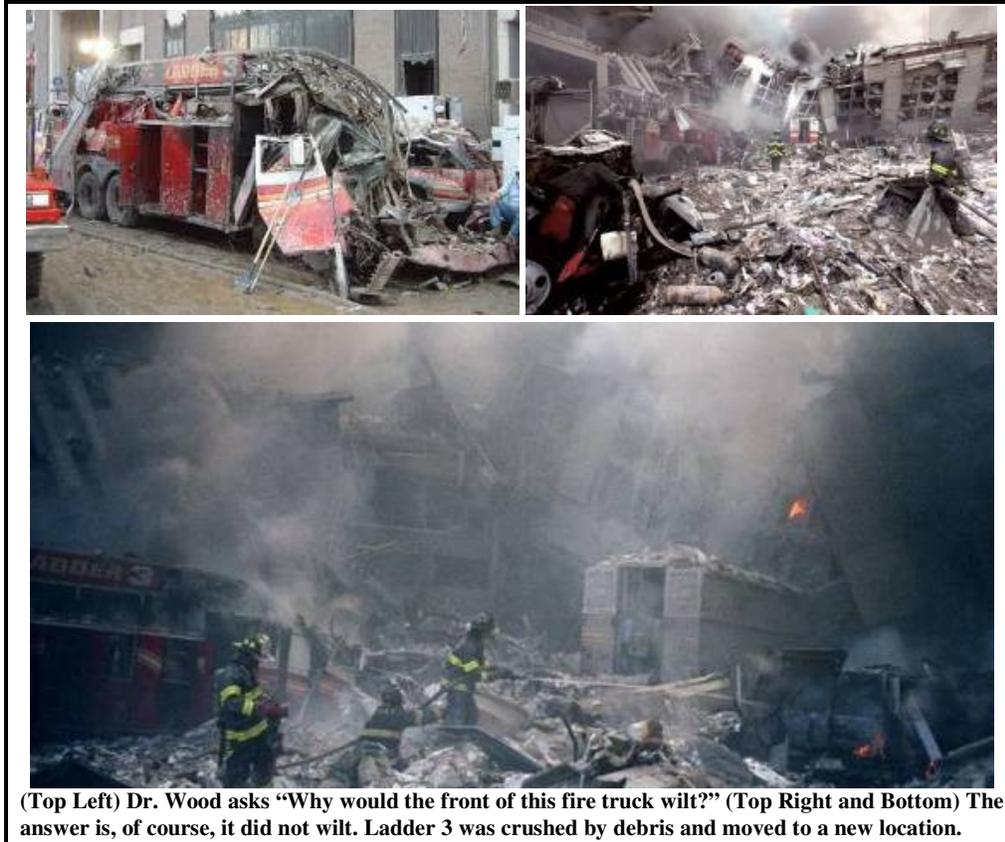
The idea that vehicles which have been smashed and then moved is vividly illustrated by the analysis done by ‘totovader’ showing the Ladder 3 fire-truck crushed by debris at ground zero (and shown below).<sup>ii</sup> However, Dr. Wood on her website asks “Why would the front of this fire truck wilt?” implying that it was not crushed by debris and moved to a new location. The videos were released *last year*, yet the obvious misinterpretation remains on her website among a litany of other discredited items.

Not only are there photographs, there exist eyewitness accounts of the placement and condition of the Ladder 3 fire truck:

*Vincent Forras is one. Forras answered the call for help as a volunteer firefighter on the morning of September 11, driving down from upper Westchester county north of the city. “My first sight upon arrival on the scene was seeing Ladder 3 totally crushed by a large block of the building and twisted into pieces.”<sup>iii</sup>*

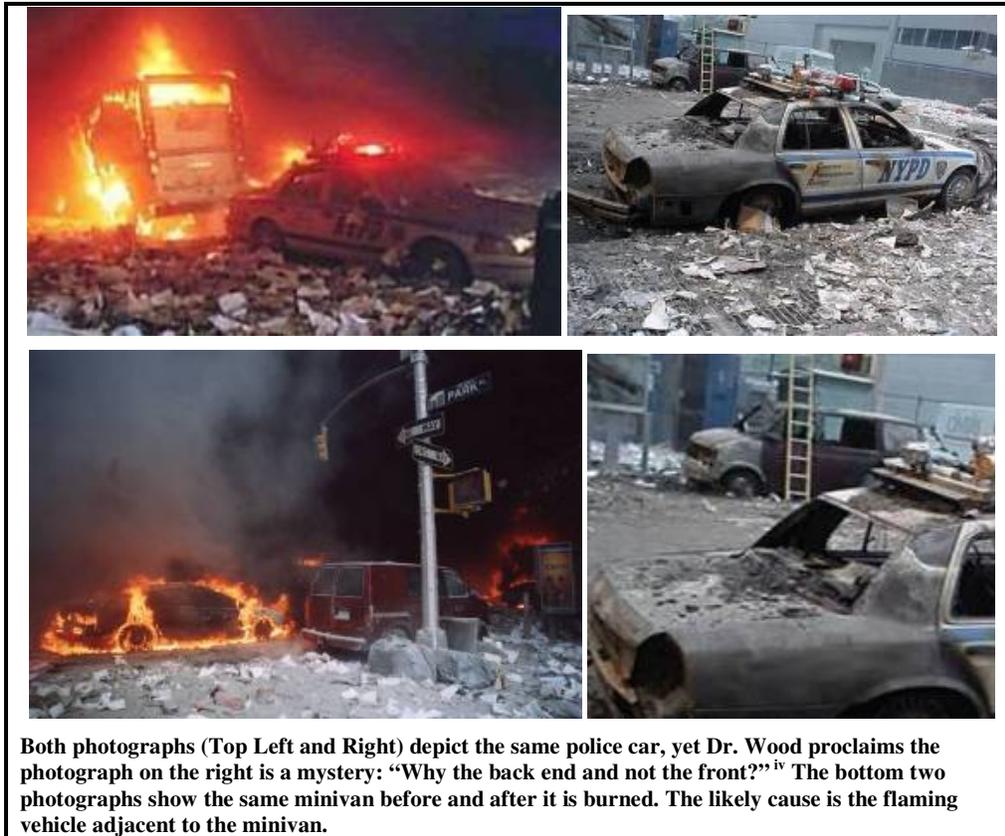
Furthermore, she erroneously presents a picture of a police cruiser in Figure 43 within her RFC to NIST<sup>iv</sup> whose causal mechanism responsible for the rear-end charring of the vehicle was previously presented in photographs and published.<sup>v</sup> There were flames from another vehicle immediately behind the police car. Before and after pictures show the highly likely cause and effect, yet she insists on continuing to promote her misinterpretation by ignoring the published evidence.

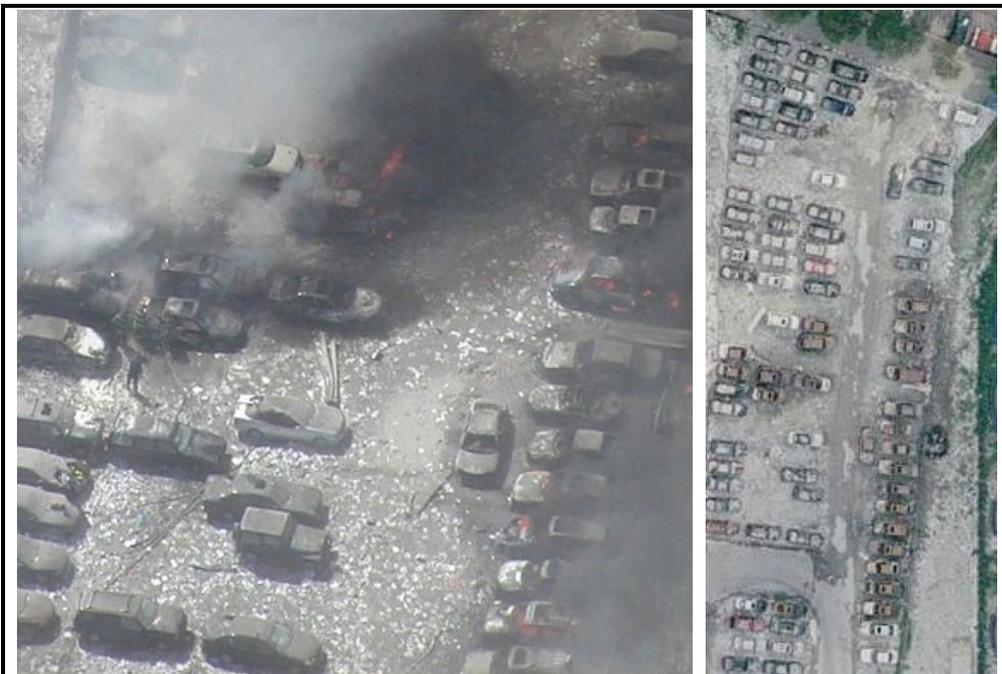
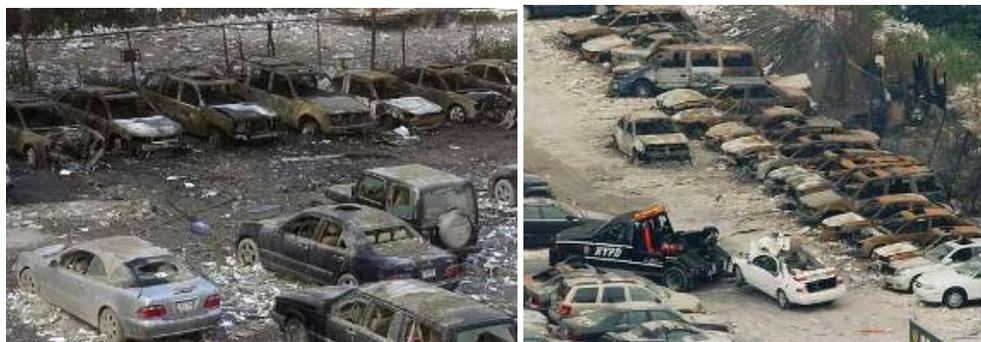
A parking lot located on the north-west corner of Vesey and West Side Highway approximately 700' from the North tower. A double parked car at a right angle to the other vehicles provides a common reference point in all photographs (the bottom left photographs shows the front-end tip of the vehicle's front bumper on the left side of the photograph). (Top Left) Fires rage as a fireman begins extinguishing flames. (Top Right) One cluster of about 7 burned vehicles, a row of about 16 burned vehicles, and one burned vehicle in the lower left (Bottom Right) The row of burned vehicles is clearly seen, and the NYPD tow truck makes a left-hand turn, by a partially burned or rusted vehicle. (Bottom Left) Notice how less paper appears in the vicinity of burned cars since the paper has burned away. Also notice the damp ground.

The characteristic pattern for serial-type burning is illustrated by the clustering of burned vehicles in the Vesey/West Street parking lot. A row of 16 vehicles has burned, and another cluster of about 7 vehicles. Firemen put out the flames arresting further serial-type burning from occurring in the parking lot. Certainly, serial-type burning could easily describe nearly all the burned vehicles. The manner in which the initial one or two vehicles ignited is unknown. However, not knowing what ignited one or two vehicles should not be confused with proof of a DEW, no more so than the K-Mart parking lot video.

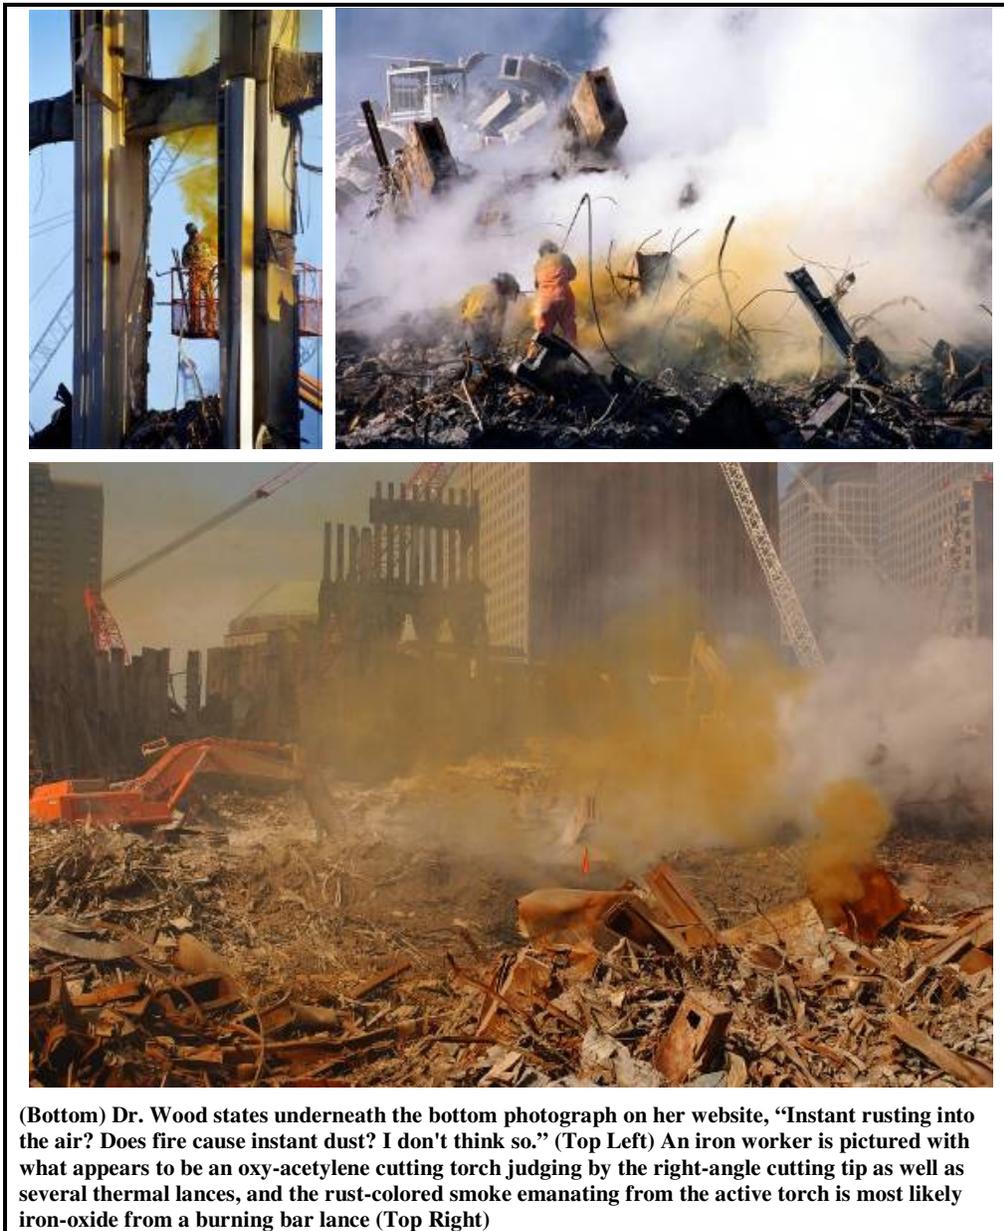
The ‘rust-colored’ smoke is not produced from steel spontaneously dissociating into rust-colored aerosols. The top two photos show rust-colored smoke which is obviously generated from the torches used in the cutting process. In particular, the top left photograph shows that the smoke emanates from whatever the man is burning since he is not, at that instant in time, cutting steel. The bottom photo is posted on Dr. Wood’s

website as evidence steel spontaneously converting to rusted iron-oxide particles. However, it is clear from the photograph that there is a trough behind the dense rust-colored plume to the right. The foreground material (bits of rusted steel debris) is different than the finer debris resembling dirt behind it which is itself distinguishable from the material at and behind the orange back-hoe. Based upon the top two photographs, it is easily surmised that a person is in the trough cutting steel in the vicinity of the rust-colored smoke emanating from the foreground material. The smoke appears to be coming out of the end of a box beam which is acting like a chimney. The beam extends back to the location of the small red flag. Directly to the right of the small red flag is a worker's helmet and his right ear is visible. He is most likely cutting the box beam.

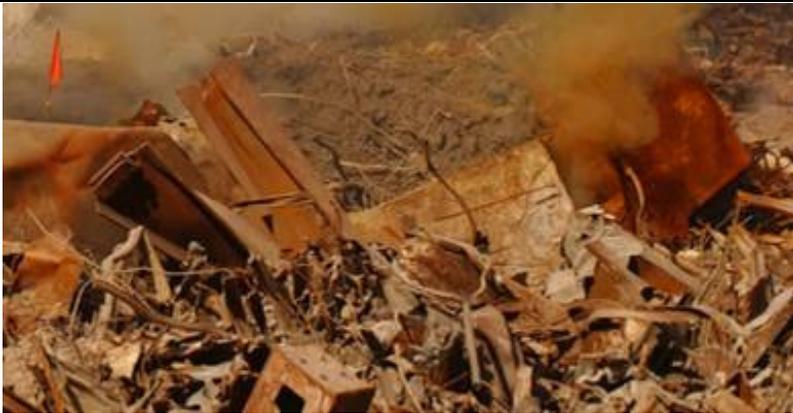
**Both pictures are progressive magnifications of the same photograph presented previously. The top picture shows the box-beam channeling smoke like a chimney. Both photographs show a man's helmet and right ear. He is presumably cutting the box beam.**

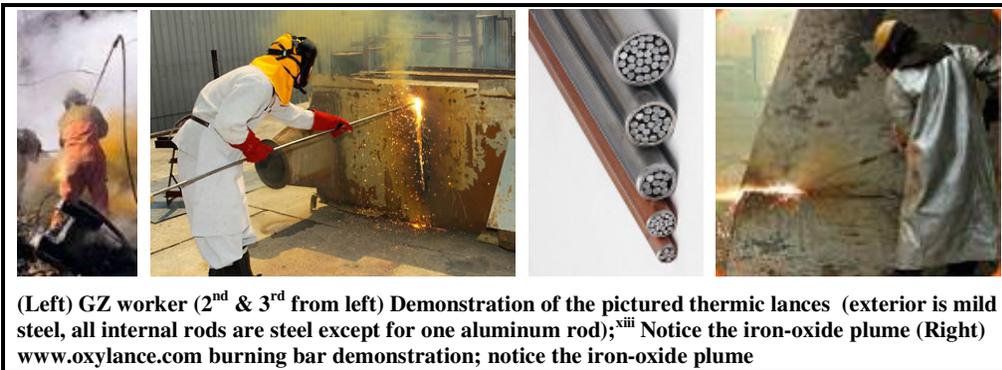
A cursory look at various oxy-lances reveals they emit the characteristic iron-oxide rust-colored smoke while cutting.

A third method utilizes oxygen lances/burning bars, a tube filled with small rods of mostly iron<sup>xiii</sup> with a large flow of oxygen directed through the tube. The bar is consumed during cutting. This tool cuts both thick steel and masonry extremely well.

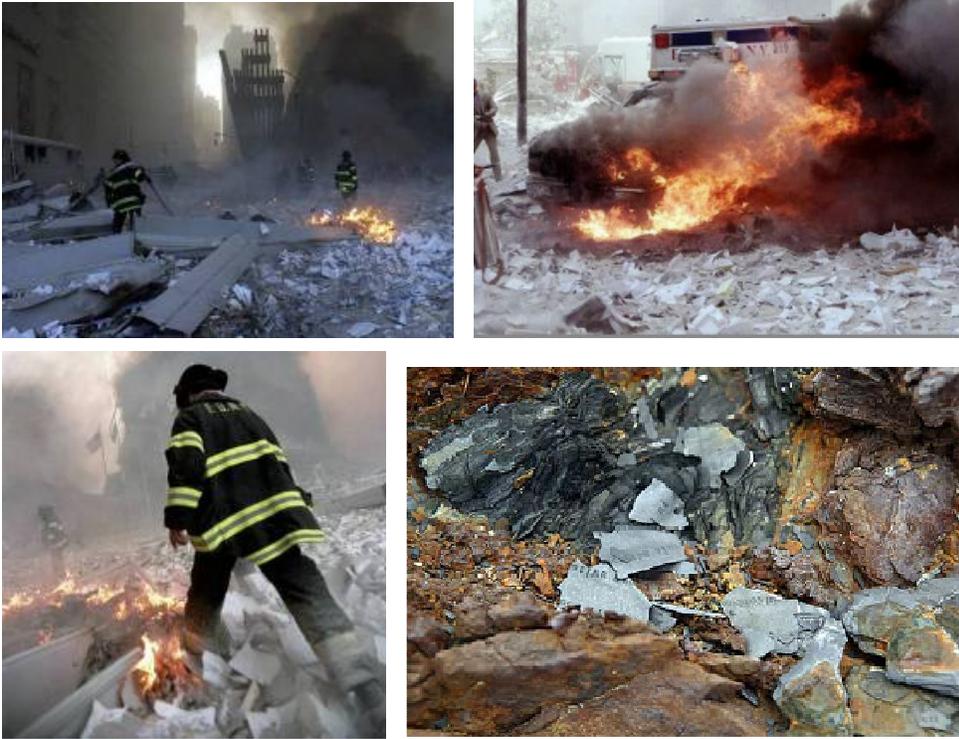
Burning paper in the vicinity of ground zero (Top and Bottom Left) Burnt and burning paper by an ambulance at Church and Dey (Top Right) Carbonized stacks of paper compressed in a 'meteorite' removed from the sublevels at GZ (Bottom Right)

Contrary to assertions by DEW-demolition proponents, paper burned at ground zero. There are photographs of charred stacks of burned paper in the WTC rubble (photograph below) and eyewitness accounts of burning paper raining from the sky.<sup>v</sup> The flames from vehicles would have surely ignited at least some paper (clearly evident at the Vesey/West Street parking lot illustrated in the next section), and the photographs which show vehicles ablaze lack sufficient resolution to distinguish burning paper from other flaming organics that can occur on the ground beneath burning vehicles under normal circumstances. Sheets of loose paper completely burn in a matter of seconds which may constitute the statistical reason that few photographs exist of distinguishable individual sheets of paper burning although some do exist. The explanation for lack of photographic evidence of burnt single sheets of paper is elementary: spotting small, crumpled, black remains of burnt paper from photographs is near impossible upon a background consisting of various sorts of dark debris and dust.

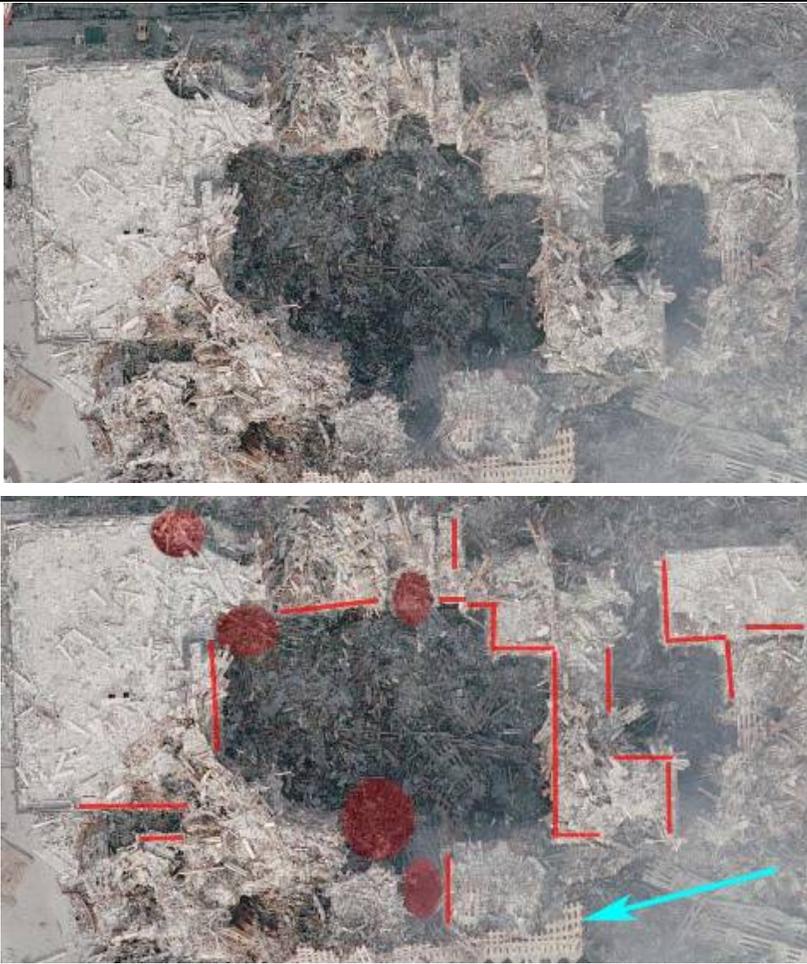
The above is an aerial view of WTC 6. The damage is often cited in support of the claim that the 'circular' holes are caused by a DEW. However, many more straight edges, corners, and jagged edges exist than partially elliptical damage. The methodology is implicitly flawed.

Damage to WTC 6 is often cited as proof of DEW-demolition because of the presence of circular holes. However, there are many more straight edges and right-angle corners using the exact same photograph. Using the simplistic methodology employed by DEW-demolition proponents, I count 5 *partial* elliptical holes, 15 straight edges, and 7 right angles.

As indicated, the above methodology is inherently and hopelessly flawed. An external isometric view of WTC 6 as well as from within the large hole of WTC 6 show that the damage is not so simplistically analyzed. A cyan-colored arrow marks the same position in the aerial photograph and the isometric view so that the reader can gauge the misleading aspects of the aerial photograph. When a third dimension, height, is

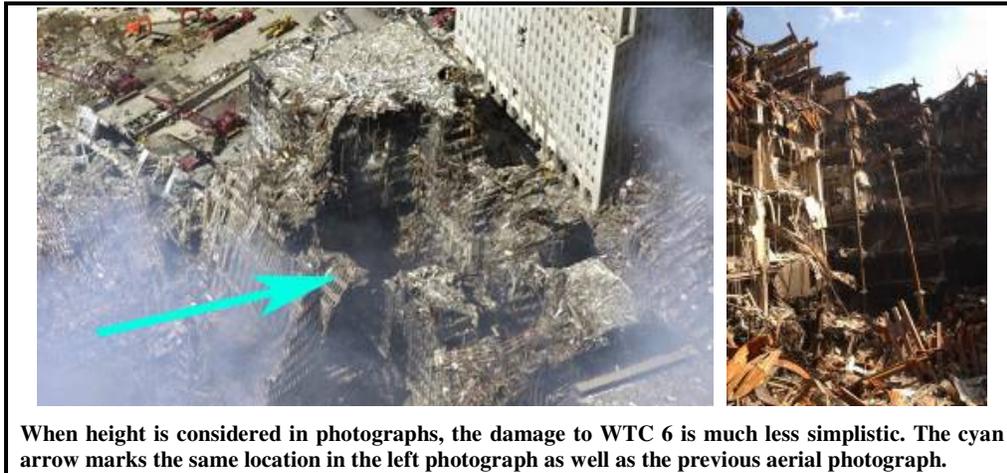
considered, it becomes apparent that much of the damage does not extend down to ground level, some damage resembles a 'stair case,' and the 'straight' and 'circular' damage is better characterized as jagged edges.

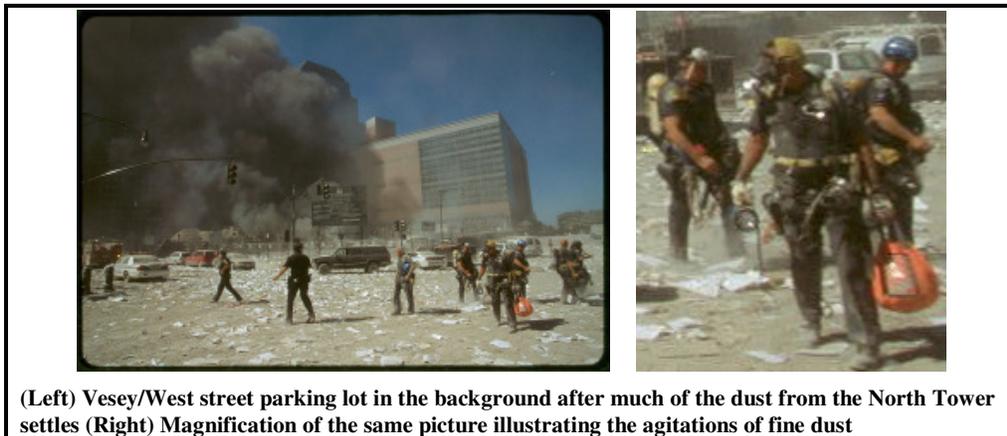
In the above photograph, she notes that the dust must have previously settled since the background sky is clear. She also notes that the Vesey/West Street parking lot is north-

west of GZ and the wind was blowing in a southerly direction. Both of these observations are correct, but she then erroneously presupposes that fine dust can not travel upwind and settle to the ground and, therefore, the fine dust which was stirred up underfoot was produced by the spontaneous disintegration of coarser material after settling out of the air.

In the previous photograph of the Vesey/West street parking lot, the fine and coarse dust settled out of the air when the air currents generated from the collapse subsided. The dust which remained in colloidal suspension was blown in a southerly direction which quickly ushered in clear skies. If the wind velocity was about 10 mph, and the dust cloud reached as far away as an entire mile north of GZ, then the prevailing wind would clear the sky in about 6 minutes once the winds associated with the pyroclastic surge completely subsided. This is consistent with the photographic record.<sup>xxiv</sup>

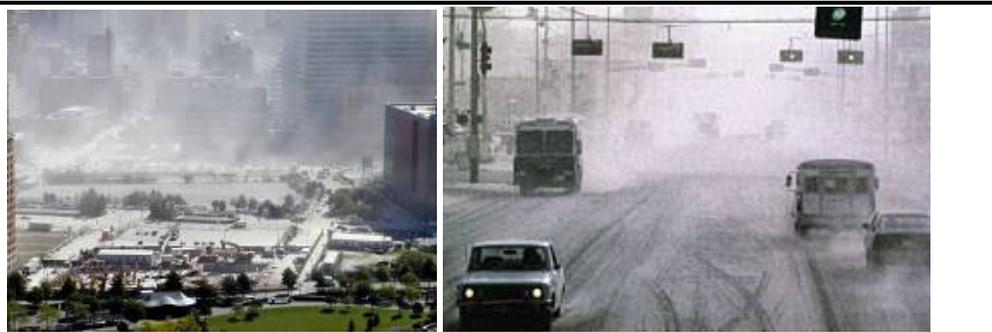
(Left) View from the west where the edge of the Vesey/West street parking lot observed on the right side of the picture. Dr. Wood on her website states: “‘Fuming’ from the cars can be seen up West Street north of the WTC complex.” Cars are not disintegrating into fine dust as she believes. Rather, the very fine dust is still settling from the collapse<sup>xxvi</sup> and dust is perturbed along roadways by traveling vehicles which have passed. (Right) Ash from Mount St. Helens—Yakima, Wash., May 1980.<sup>xxvii</sup> The photograph should not be misconstrued as the streets or cars spontaneously dissociating into fine powder.

On her website, Dr. Wood alludes to ‘Fuming’ which is in actuality agitation dust which is still settling from the air (evident from the photographic record)<sup>xxiv</sup> as well as finer dust being re-suspended into the air via agitation.

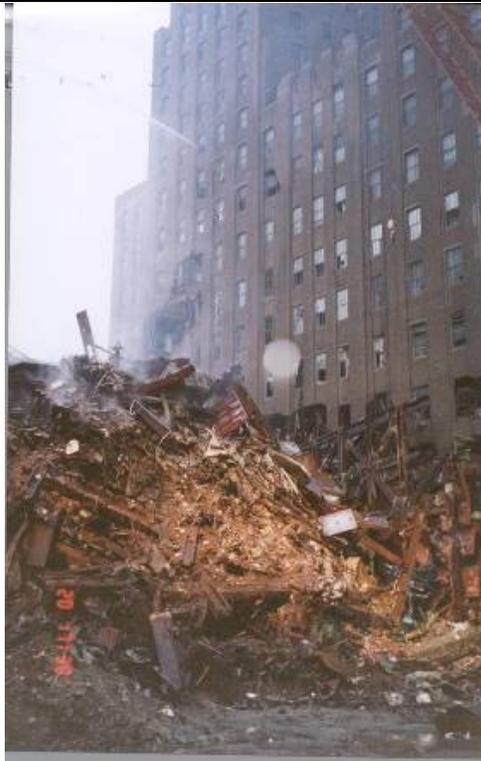
**WTC 7 debris pile: Lots of crushed debris which resembles 'dirt'.**

Photographs of the WTC 7 rubble pile (shown below) depict constituents which superficially resemble 'dirt' throughout the pile. However, much of it is actually crushed wallboard, concrete, and office furnishings which were subsequently watered down by rain and fire hoses. This is what one would expect such constituents to look like.

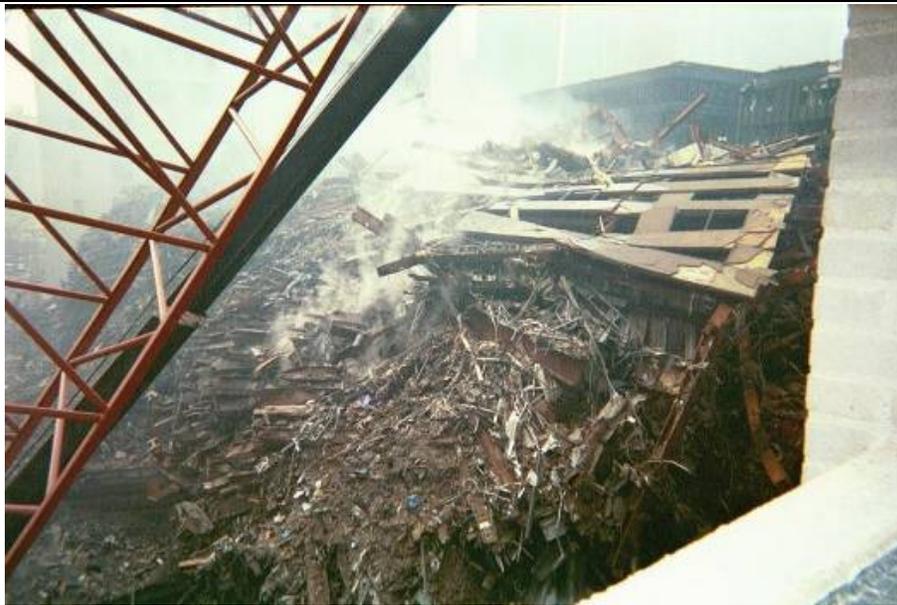
**WTC 7 debris pile:** A look from a window overlooking the rubble pile shows a close up of crushed debris which superficially resembles 'dirt'. Note that the 'dirt' could not have been dropped on the pile from above since none exists on the exterior wall lying atop the pile.
